**US Army Corps
of Engineers**
Waterways Experiment
Station

Technical Report REMR-CS-61
June 1999

An Evaluation of Equipment and Procedures for Tensile Bond Testing of Concrete Repairs

*by Alexander M. Vaysburd, Structural Preservation Systems, Inc.
James E. McDonald, WES*

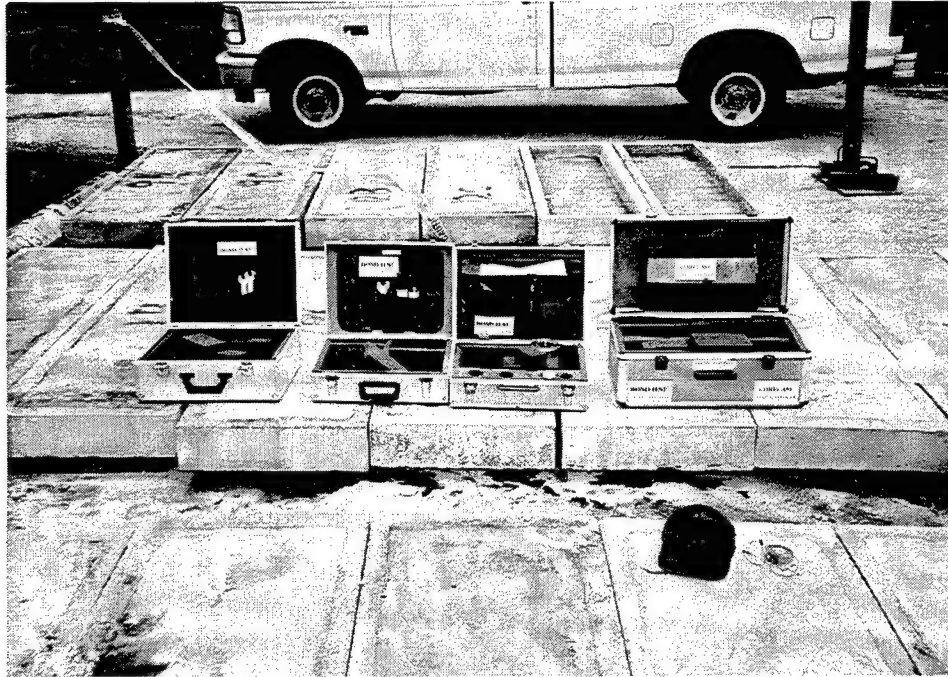
Figure 3. Germann Instruments testing equipment at the jobsite (Florida)

The equipment consists of four kits: preparation kit, pull machine kit, corecase kit, and DSV kit (Figure 3).

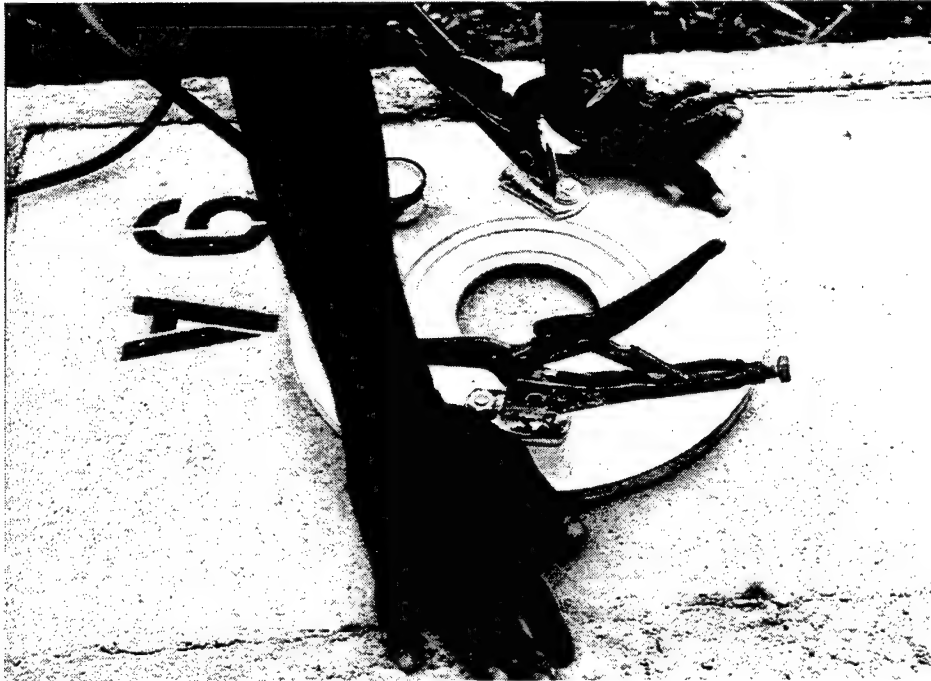
Figure 4. Attachment of vacuum (suction) plate

- a. The test surface is planed dry with the diamond surface planing wheel attached to the suction plate (Figures 4 and 5). The corner knob is removed with a grinder and the surface brushed free of all dust (Figure 6).

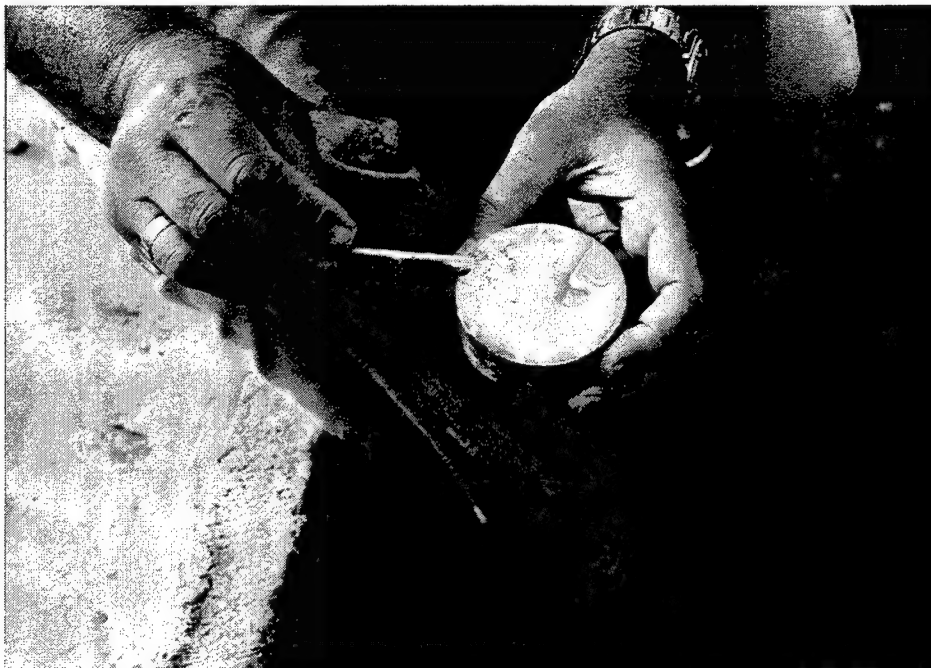
Figure 7. Application of adhesive

- b. A 75-mm (3-in.) diameter and 30-mm (1.2-in.) thick steel disc is applied with special fastsetting glue to the repair surface inside the suction plate by means of the centering plate and pressed firmly against the surface with the adjustable pliers (Figures 7 and 8).

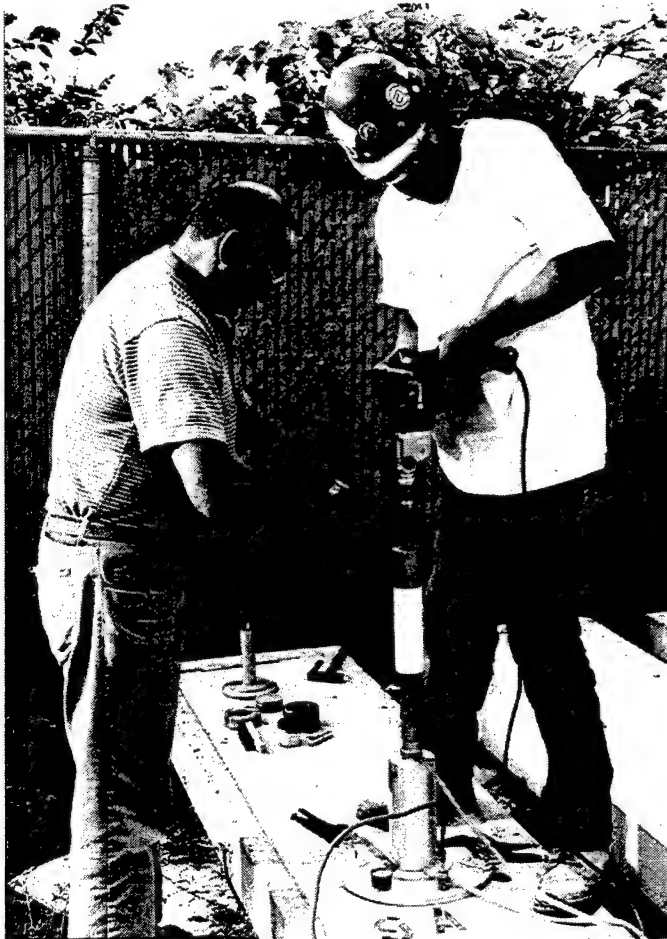
Figure 9. Core drilling

- c. The glue usually hardens in 2 to 5 min depending on ambient temperature.
- d. The corecase assembly is fitted around the disc and attached to the suction plate. Drilling takes place to the required depth (Figures 9 and 10).

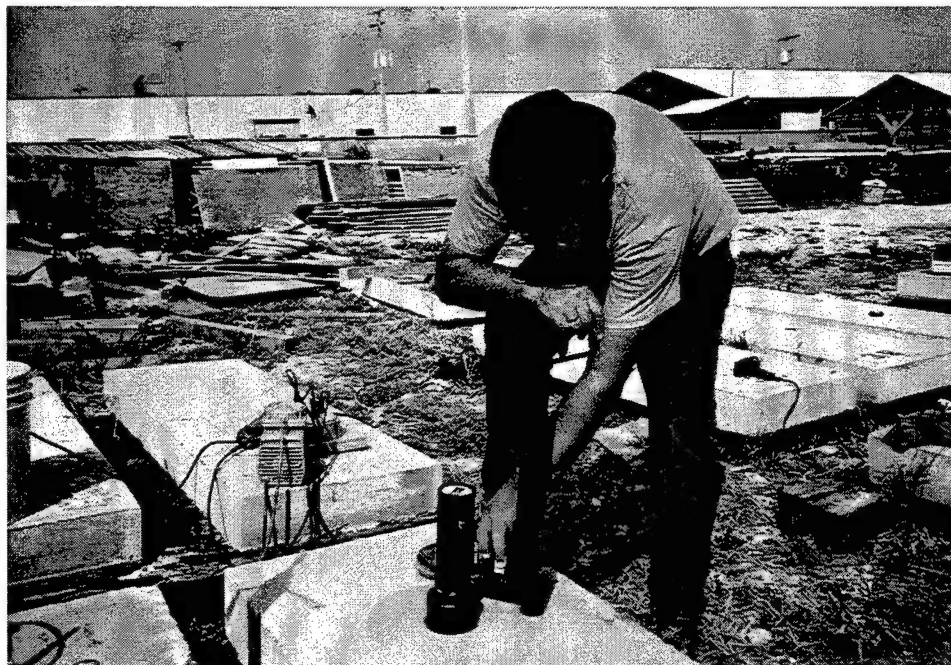
Figure 11. Geramm Instruments pull-off testing

- e. The bond-test hydraulic apparatus is connected to the steel disc resting against the counterpressure frame and loaded by hand (Figure 11). Loading takes place with a constant loading rate to rupture the drilled core at the weakest location.

- f. The peak load is recorded to the nearest 0.1 kN (22.5 lb) and transformed to pull-off strength. The pull machine is equipped with an electronic Microprocessor Gauge.

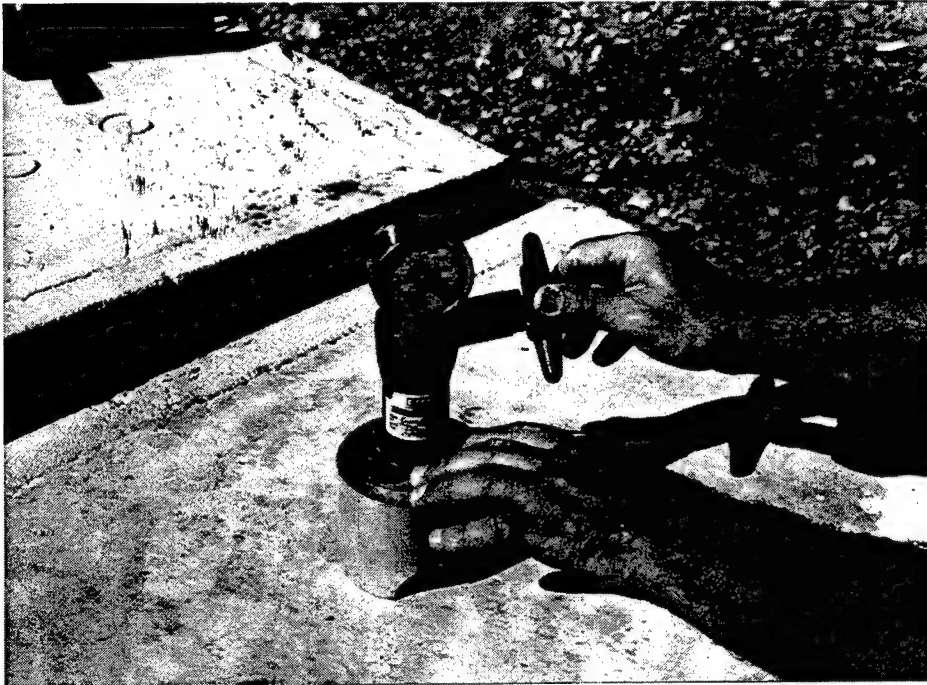
Figure 15. Testing with Hilti tester

The Hilti tester is a special apparatus originally designed to measure the pull-out strength of embedded anchors. The apparatus was modified by Structural Preservation Systems, Inc., to measure pull-off bond strengths (Figure 15).

The tester has a maximum tensioning force of 8.9 kN (2,000 lb), with gauge scale graduation to 89 kN (20 lb). The device is small, lightweight, and mobile to use in any location. It has an inconvenient hand-wheel drive that does not allow for uniform load increase. It is not equipped with any devices to position it at a right angle to the surface.

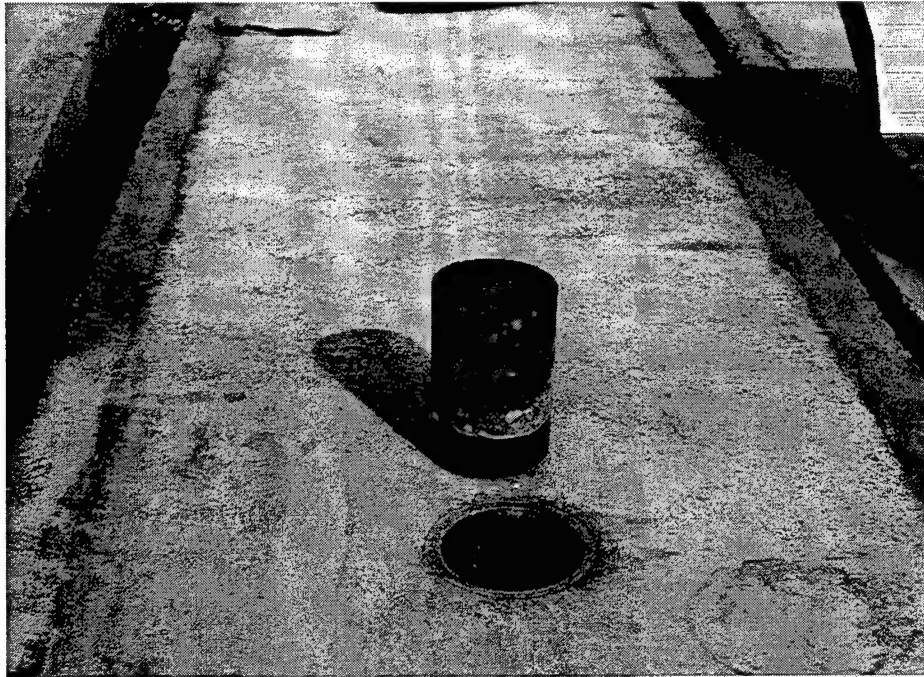
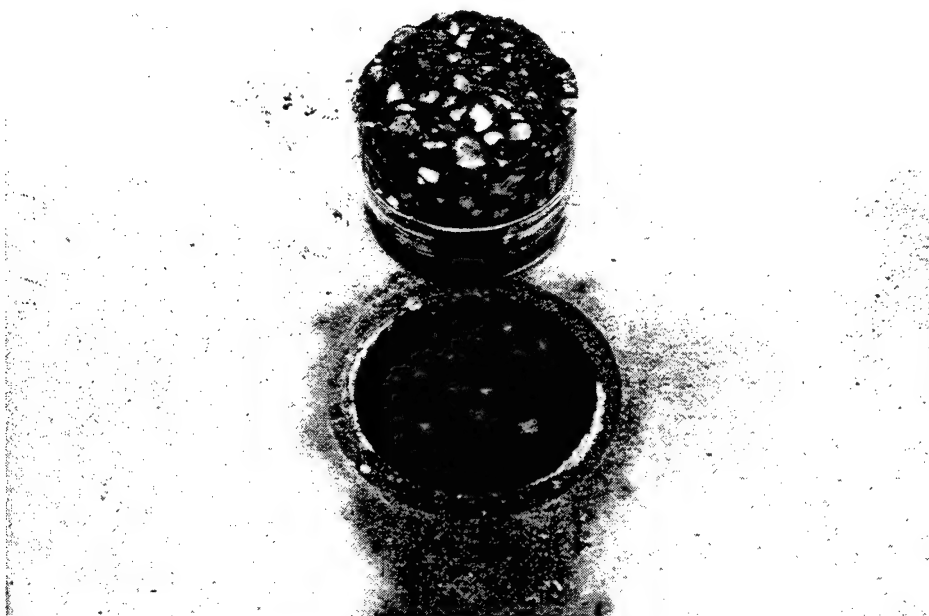
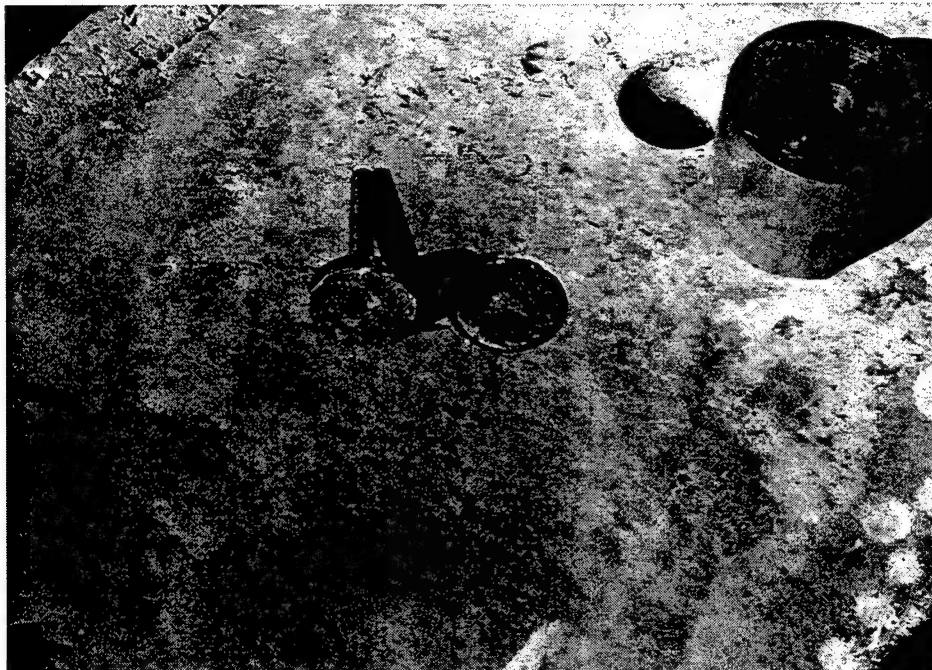
Figure 21. Failure at repair-substrate interface

Figure 22. Failure in substrate concrete

Figure 23. Failure in repair material

Figure 24. Failure at disc-repair interface

The average test results for each material, mode of failure for each specimen, and standard deviation and coefficient of variation (COV) between the three pull-off tests for the same material performed by each testing device are presented in Tables 2-10. Examples of different modes of failure are shown in Figures 21-24.

An analysis of the modes of failure demonstrates that in the 239 tests performed in this series, 98 failures (41 percent) occurred in the concrete substrate, 61 failures (26 percent) occurred at the repair-substrate interface, 49 failures (20 percent) occurred in the repair material, and 31 failures (13 percent) occurred at the steel disc-repair interface. Of the 31 failures at the steel disc-repair interface, 22 failures occurred within the epoxy adhesive at bond strengths in excess of 1.4 MPa (200 psi).
